<b>Job ref:</b>	<b>2811</b>	<b>Test Sample:</b>	<b>New Design</b>
<b>Test Details</b>		<b>Observations Prior To Testing</b>	
Design weight:	25.00 kg	Final load is to be held for 5 minutes to allow the material time to settle.	
No. increments:	10	No defects observed prior to testing. Displacement in the direction of load application positive.	
Date:	19/08/2022	Measurement devices located as below:	
Technician:	TT	POT1	End span
Base Material:	Masonry		
Fixing Type:	FRIULSIDER X1 EVO X1 EVO HIGH-PERFORMANCE NYLON PLUGS 10 X 70MM	<b>Observations During &amp; After Testing</b>	
		No visual sign of the fixings pulling out and the test piece achieved a high percentage of recovery.	
		No further defects observed during testing.

New Design

Old Design

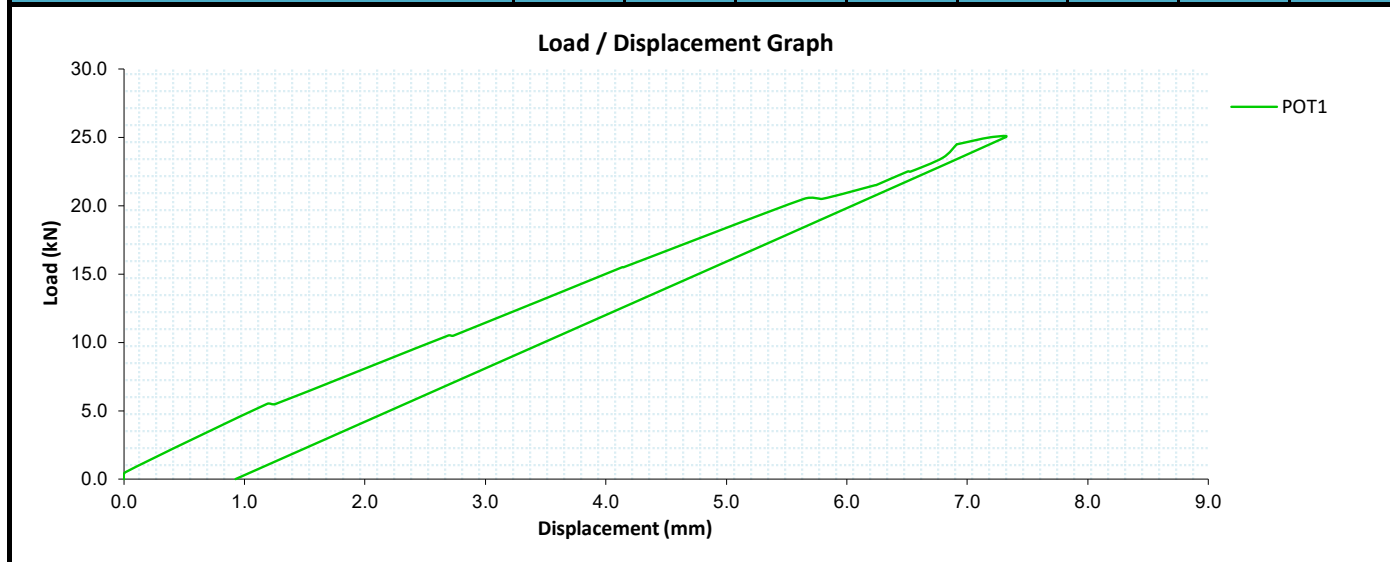
Load Values			Displacement (mm)						
Mass/Fixing (kg)	Time	POT1							
0.00	10:29:00	0.00							
0.50	10:30:00	0.01							
5.50	10:32:00	1.19							
5.50	10:37:00	1.26							
10.50	10:37:00	2.69							
10.50	10:42:00	2.74							
15.50	10:47:00	4.14							
15.50	10:52:00	4.15							
20.50	10:57:00	5.64							
20.50	11:02:00	5.79							
21.50	11:07:00	6.24							
21.50	11:12:00	6.24							
22.50	11:17:00	6.50							
22.50	11:22:00	6.53							
23.50	11:27:00	6.79							
24.50	11:32:00	6.91							
24.50	11:37:00	6.92							
25.00	11:42:00	7.19		#N/A	#N/A	#N/A	#N/A	#N/A	#N/A
25.00	11:47:00	7.31							
0.00	12:00:00	0.93							
<b>Max displacement (mm)</b>		<b>7.31</b>							
<b>Recovery (%)</b>		<b>87.3%</b>
